TURBINE INSULATION

- Project:**
Turbine Insulation
- Client:**
Peter Brotherhood Limited
- Location:**
Peterborough, UK
- Time Scale:**
10 days (working)

CASE STUDY

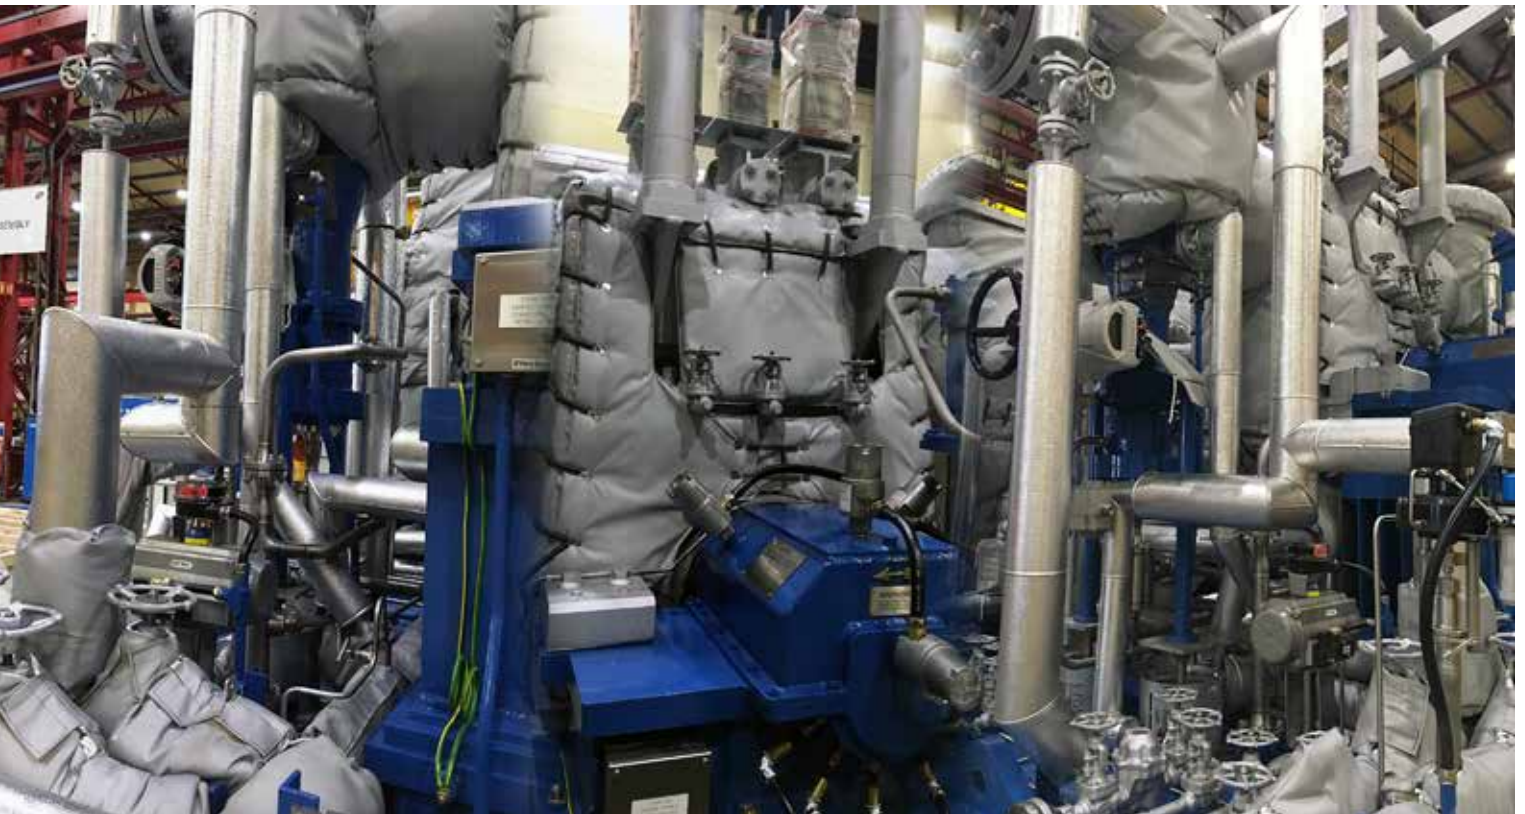
Installation of foil faced mineral wool insulation protected with stucco aluminium cladding to the Oil and Steam pipework on the turbine. Areas where it was not achievable to use previously stated methods such as valves and flanges, removable jackets were fitted and manufactured from a grey silicone cloth with a mineral wool insulation filling secured with Velcro and drawstrings.
